Preventing Whip Damage in Optical Fiber Processing

Application Note

Issued: May 2007

AN3010

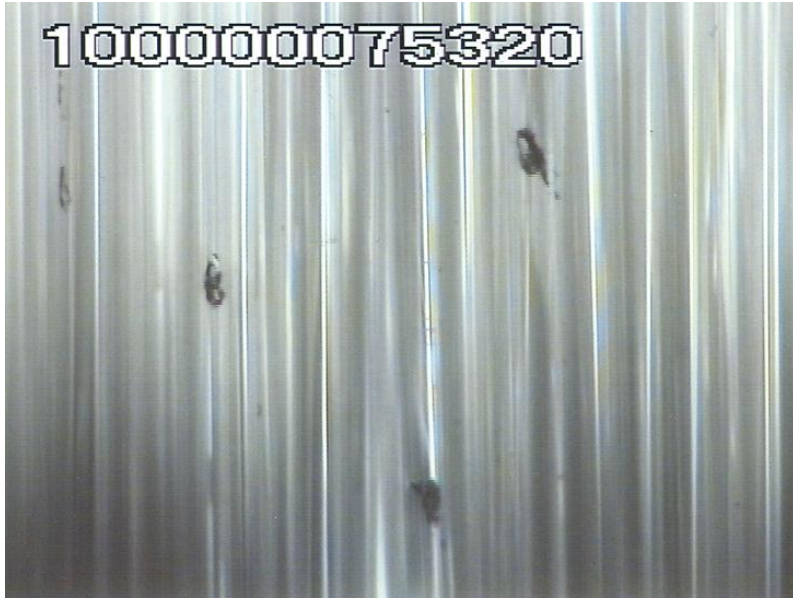
The outer surface windings of a reel that has been whipped by a fiber end may present blemishes in the coating (visible at low magnification in good lighting) where the fiber end has penetrated the coating (see Illustration 1).

Illustration 1. Surface of a reel with surface blemishes generated by fiber end whip

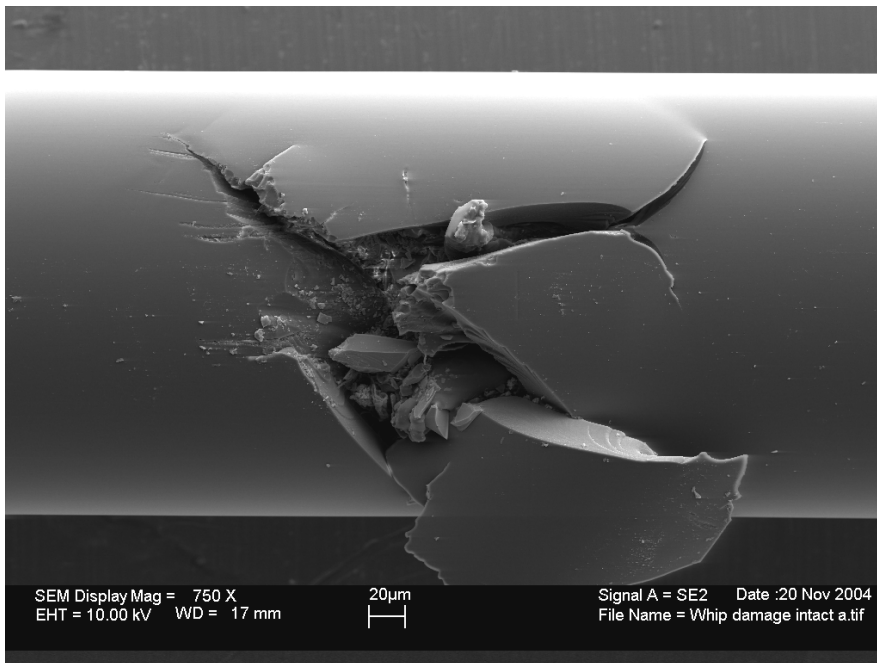
When the break end of a whipped fiber is inspected under magnification, characteristic damage to the polymer coating may be observed (see Illustration 2).

Illustration 2. Coating cracks introduced by fiber end whipping

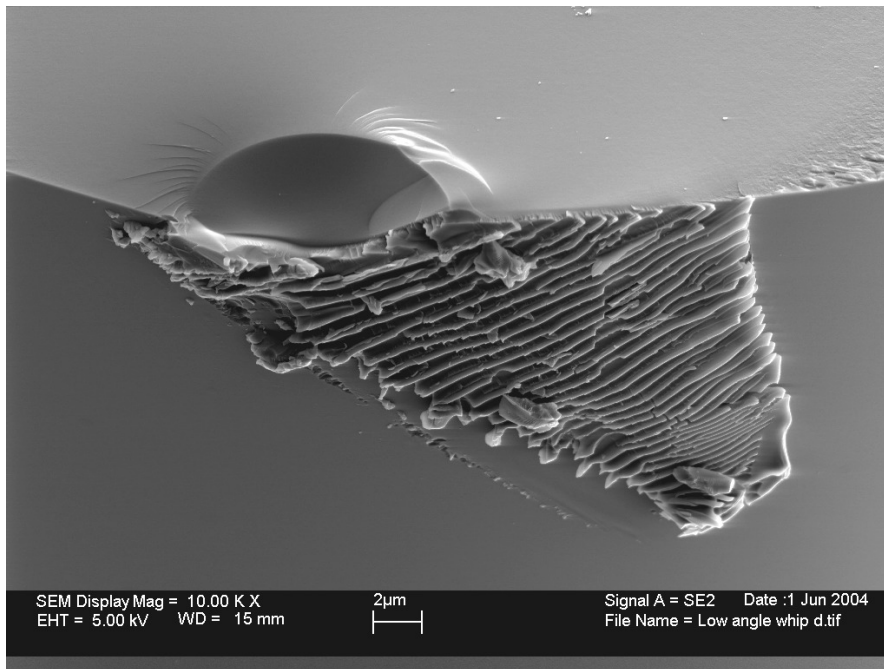
Viewed side-on with the coating chemically removed, whipping may be identified by with deposition of a glass “plough” on the surface of the cladding at the impact site. The plough feature is believed to result from localized melting of the glass when energy is dissipated during this high speed contact event (see Illustration 3).

Illustration 3. Glass deposition on the cladding surface following a whip impact which caused this fiber to break.

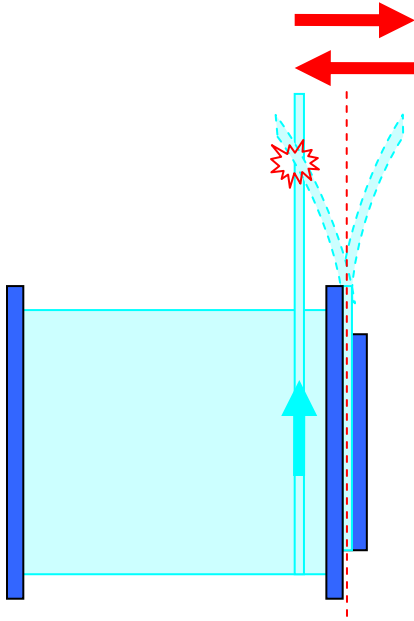
A schematic of the manner in which the inner end may induce whip damage is presented (see Illustration 4). If the inside end of the fiber is free during the rotational pay-out of fiber, the length straightens along the spool radius under the influence of centrifugal force. Although the pay-out fiber path is typically away from the nearest flange, turbulence or contact with part of the processing equipment machinery during traversing motion, may be sufficient to cause the fiber end to flap around and deflect back into the fiber path, generating whip damage as fiber is paid off. It is also conceivable that, if the inner end is unsecured and sufficiently long, the fiber end could flap back into the outer surface of the fiber reel and induce the type of damage indicated in Illustration 1.

Illustration 4. Turbulence causes the unsecured inner end to strike fiber in the pay-off path.

1. At the pay-out reel (particularly in coloring where the rotational velocity of the reel is greatest) ensure that a long inner end is not allowed to become detached from the outside of the flange. This may be achieved by cutting the inner end close to the slot and operating with the slot plug in position. Alternatively the inner end may be cut close to the slot and secured by a sufficiently well adhered sticker. See Corning Application Note 3683 for recommendations on cutting the

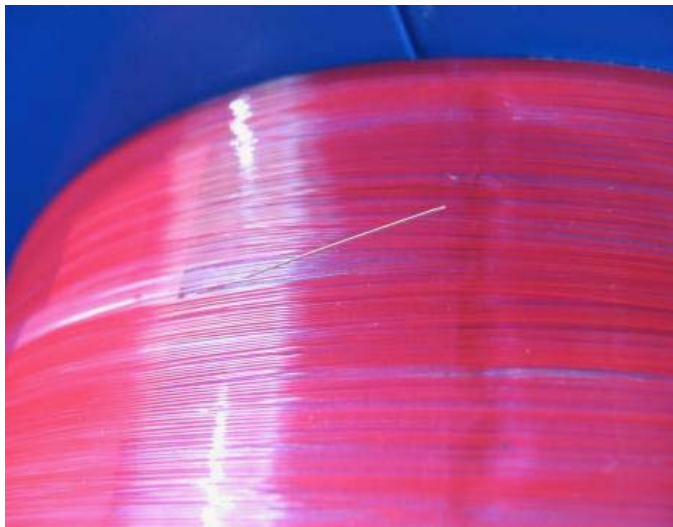
Corning has encountered situations where the inside end is attached to the barrel of the take-up spool (rather than the flange) with tape or a sticker to cover the end. This arrangement is not recommended due to the fact that tape and stickers can release from the barrel during reel rotation and allow the fiber end to protrude from the fiber pack as shown in Illustration 5. This fiber end is now free to cause whip damage. The fiber should be attached to the flange rather than the barrel.

Illustration 5. An example of fiber-end whip source caused by insufficient adhesion of the fiber end to the barrel using a sticker.

2. At the take-up reel, secure the fiber from the pay-out spool (after threading up through the machine) by passing it through the slot and securing to the lead-meter side flange. Carefully rotate the take-up spool by hand to remove any slack in the fiber path. Do not attach fibers to the spool barrel.

3. When securing fiber ends with stickers or tape, ensure that the sticker is properly applied to cover the fiber end and the adhesion is sufficiently strong so as to remain in place when the spool begins to rotate. Use stickers only once - do not attempt to re-use stickers for multiple reels.

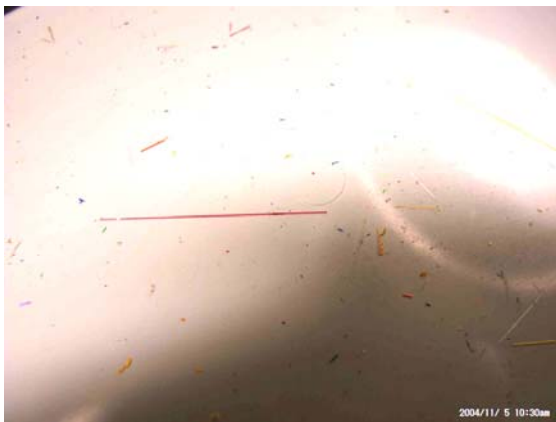
Finally, it needs to be recognized that when whip damage leads to a break event, the shattering of the fiber may lead to the generation of fiber shards in the region of the processing equipment. If not efficiently removed from the area, these shards may become mobile in the circulating air, lodge in the fiber path and propagate more breaks through penetration by the shard of the coating to damage the glass. Illustration 6 shows a coloring surface from which debris from previous breaks has not been removed, leading to the probability of further breaks on the line.

Illustration 6. A coloring surface contaminated by shards from previous break events

5. Immediately following a break event ensure a thorough clean-down procedure is followed to eliminate glass shards from the area of the processing equipment. Appropriate cleaning following a break can include vacuuming of the processing surfaces and applying an alcohol soaked cloth to wipe down the pulleys, capstans and dies of the fiber path. A sharps bin should be conveniently located close to the processing equipment to dispose of any shards or fiber ends generated in operating the equipment. If a break is suspected to have induced whip damage in the outer surface windings, remove sufficient fiber from the outside of the reel to ensure the damaged section is eliminated. This prevents more breaks being propagated in further processing. Removal of up to 2 km of fiber may be required for this purpose.
