Fracture Analysis, a Basic Tool to Solve Breakage Issues

Technical Information Paper

Display
Technologies

TIP 201

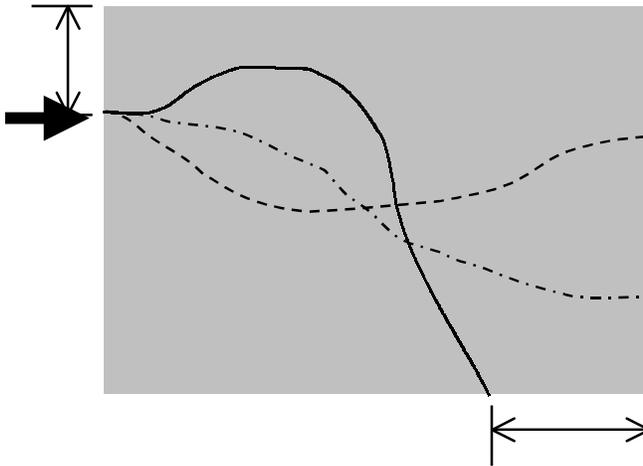
Fig. 8 Crack map of three broken sheets.

In the case, crack map of three broken pieces were obtained as shown in Fig. 8. One of two crack ends on each broken sheet are located at same position (arrow mark). This information indicates that probability of existing origin at this point is high. If a machine creates damage, its location is precisely same due to its high repeatability to compare with manual.

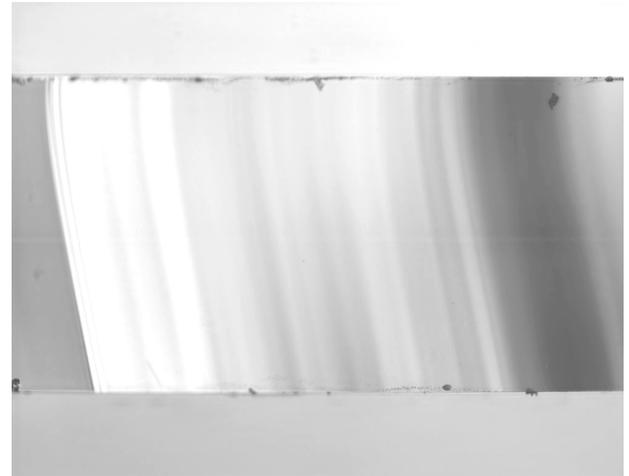
The crack propagation direction is identified with observation of the Wallner lines or Hackle marks to look for a location of origin of the breakage. Not only the crack propagation direction, but also type of the applied stress can be identified from the results of this observation. In the case, wallner lines which is almost perpendicular to the surface are seen in the middle of fracture surface as shown in Fig. 9. These Wallner lines indicate two things, (1) that the thermal stress possibly contributed to propagation of this crack and (2) crack runs right to left.

Fig. 9 Wallner lines on fracture surface Thermal stress is one stress that can generate this shape of Wallner lines. Crack run right to left.

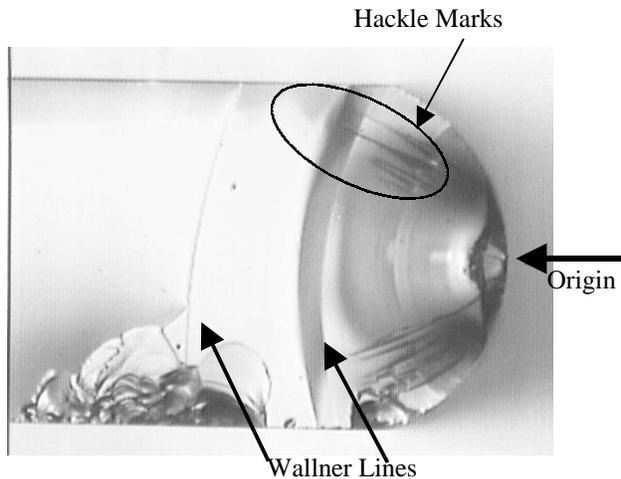
Figure 10 shows around origin. Origin can be identified at the apex of round edge (arrow mark) by (1) center of radial Hackle marks and (2) center of semi circular Wallner lines. This point was same as the point that mapping result indicated a potential location of origin.

Fig. 10 Fracture surface around origin. Radial Hackle marks, symmetrical Wallner lines with Arrest lines are existed

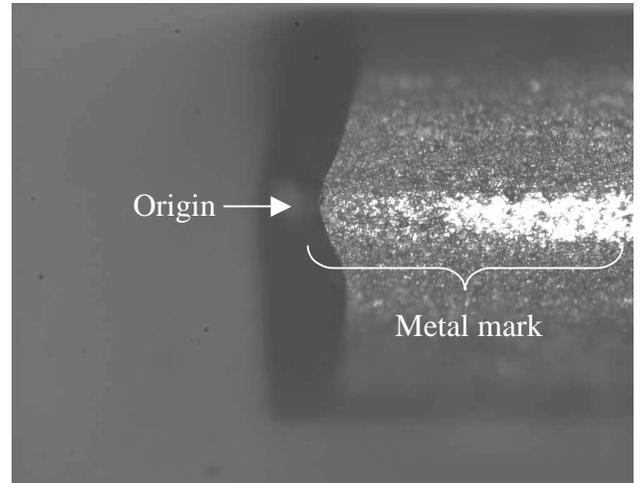
On the case, ground edge around the origin was observed, and result is shown in Fig. 11. Obtained information was:

1. There is residue, which shines brightly at the apex near the origin.
2. Due to the residue position, only at apex, it is assumed that shape of rubbed something could be bar or pin, and its direction is perpendicular to the edge direction.
3. Shape of origin is curved, and hidden cracks having same shape as that of origin was confirmed (it is difficult to see in this picture). This information says that the origin was one of Chatter marks, created by friction. And rubbing direction was identified parallel to the edge by the shape of the chatter mark.

Generally, metallic material can be seen shiny by optical microscope with reflective light source. The residue was analyzed with SEM/EDX to identify its material. The result indicated that the metallic material was Stainless steel. Preliminary summary of mechanism of origin creation is that a something made of stainless steel rubbed apex of ground edge, created Chatter mark and left metal residue. The chatter mark became origin of breakage when thermal stress was applied.

Fig. 11 Around the origin. This picture was taken from apex of the ground edge. Vertical axis in this picture is thickness direction.

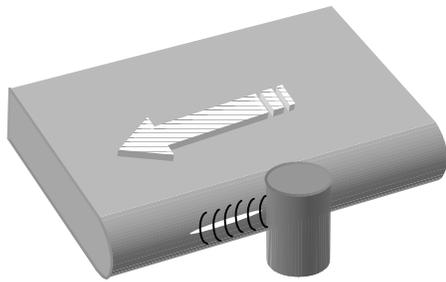
Finally, information obtained from broken piece and processes are considered to identify the breakage mechanism. In summary of this case, damage was generated by the glass edge rubbing with the alignment pin when the substrate was pushed toward the pin as shown in Fig. 12. After the film deposition, the crack propagated from the origin by tensile stress, which was created parallel to the edge when the substrate is cooled down from 200-300°C to room temperature.

Fig. 12 Schematic illustration of the identified mechanism of origin creation on the case. Actually, glass sheet slides with direction of arrow mark with fixed pin, and relative rubbing direction by pin is opposite (left to right in this figure).

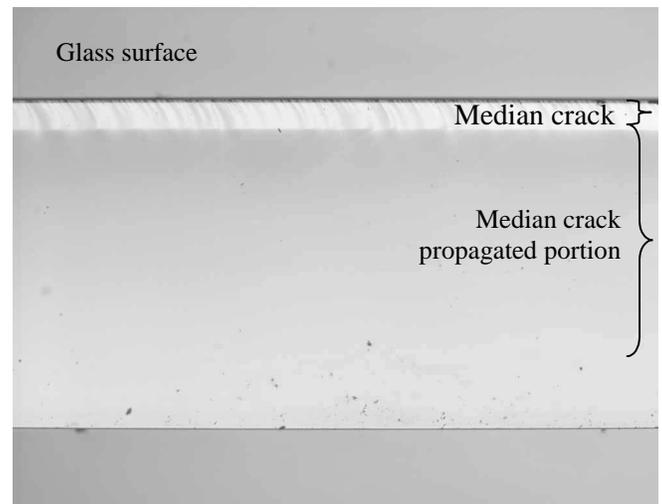
The typical fracture surface by good cutting (called “Cut surface”) is shown in Fig. 14. Median crack, approximately 100 μ m in depth is uniformly created, and the median crack propagated portion was smooth, due to low and stable breaking force.

Fig. 14 Typical fracture surface by good cutting. Median crack depth is stable, and the median crack propagated portion is smooth.

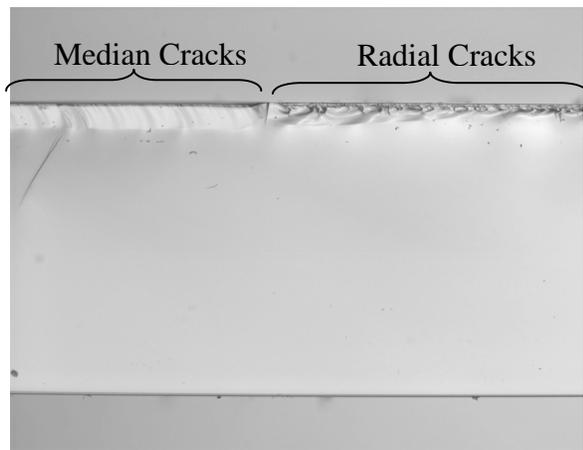
Fig 16 shows insufficient median cracks often created when the scribe wheel becomes worn or the scribe force too low to maintain the median crack. Left side median cracks created uniformly, but on the right side, radial cracks were created. The radial crack is created just front of scribe wheel contact portion. It is shallower than median crack depth at same scribe load, and wavy surface. This crack easily deviated from the scribe line. Scribe wheel run from left to right.

Fig. 16 Cut surface where the median crack stopped. Scribe wheel runs left to right.

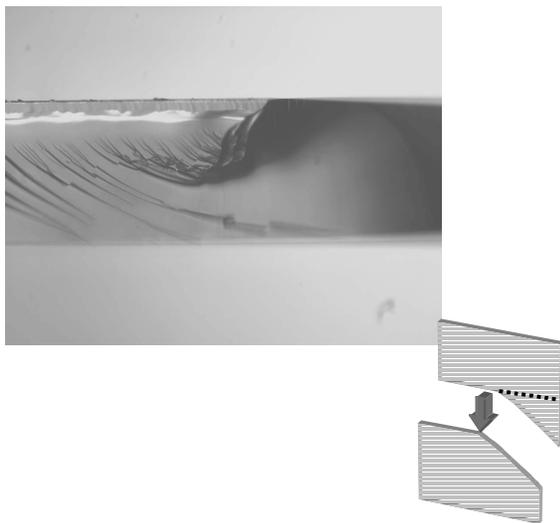
In contrast to that, Figs. 15 and 16 show some faulty cut surfaces [13]. When individual LCD cells are separated in the final stages of LCD manufacture, the fracture plane sometimes deviates from the score-line. Even when scoring is done properly, i.e., the median crack is deep enough, this break failure is (also called mis-break) can result from inappropriately applied stress during separation. In Fig. 16, although the median crack is deep enough, the fracture surface deviates from the median crack. This fact shows that the tensile stress on the opposite surface of the scribed side is higher than that on scribed side. The mechanical stress of impact during cell separation process could also provide sufficient additional stress to cause mis-break.

Fig. 15 Fracture surface of miss-breaking sheet by inappropriate separation [13].
