Preventing Whip Damage in Optical Fiber Processing

Application Note

AN3010

Issued: November 2015

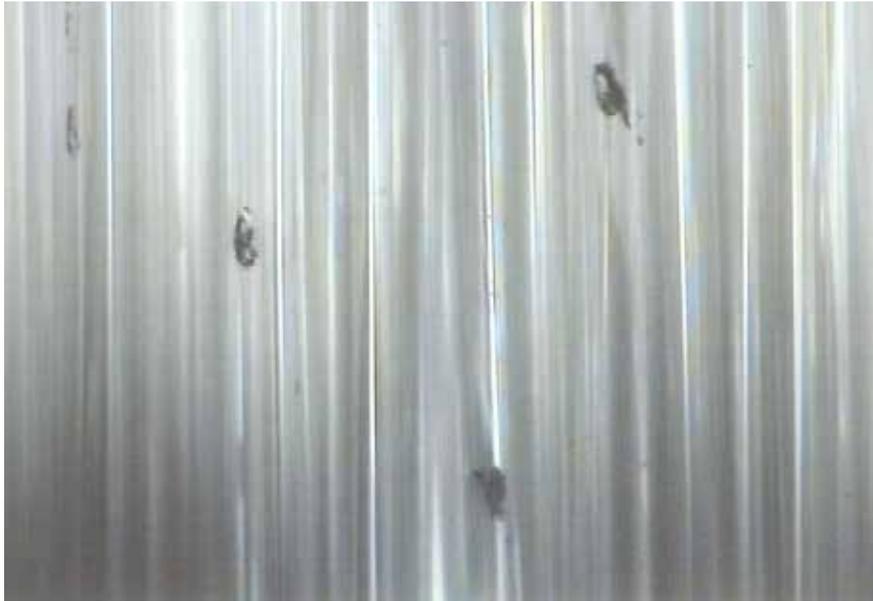
The outer surface windings of a spool that has been whipped by a fiber end may present blemishes in the coating (visible at low magnification in good lighting) where the fiber end has penetrated the coating (see Figure 1).

Figure 1. Surface layer of a spool under magnification with surface blemishes generated by fiber end whip.

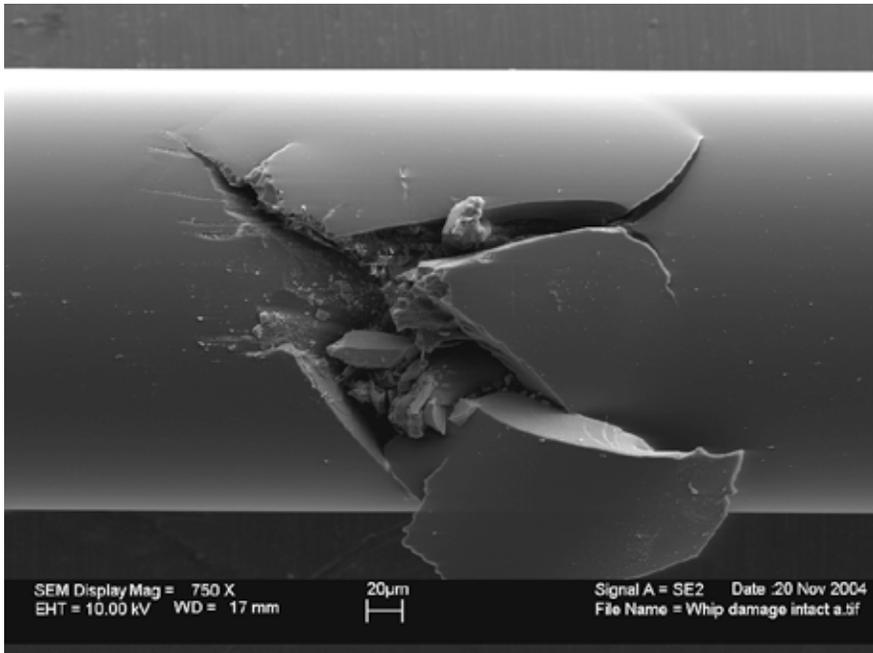
When whipped fiber is inspected under high magnification, characteristic damage to the polymer coating may be observed (see Figure 2).

Figure 2. Coating damage introduced by fiber end whipping.

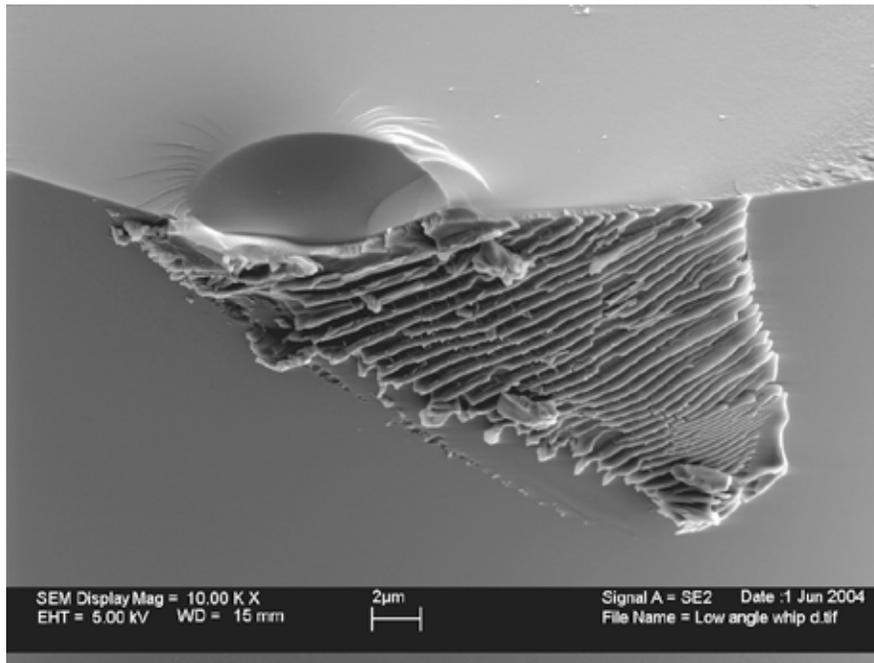
Viewed side-on with the coating chemically removed, whipping may be identified by deposition of a glass "plough" on the surface of the cladding at the impact site. The plough feature is caused by localized melting of the glass when energy is dissipated during this high speed contact event (see Figure 3).

Figure 3. Glass deposition on the cladding surface following a whip impact which caused this fiber to break.

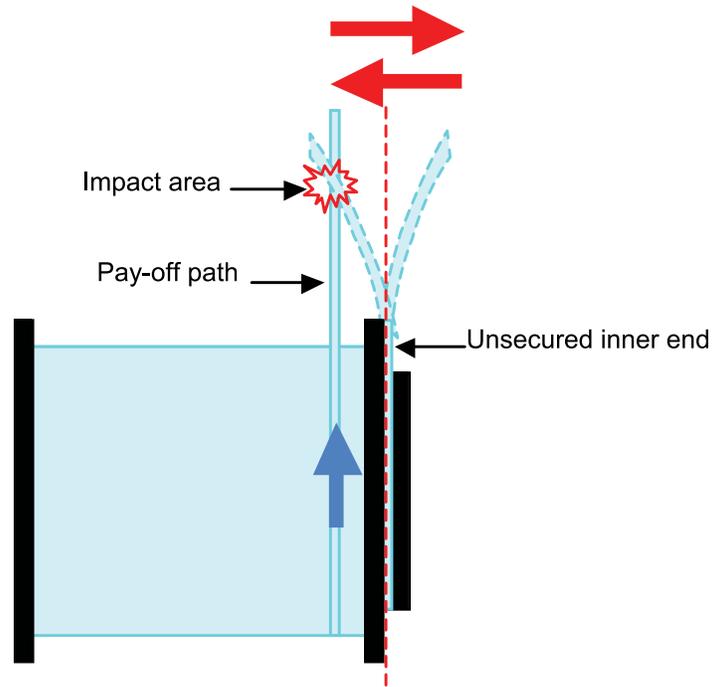
A schematic of the manner in which the inner end may induce whip damage is presented (see Illustration 4). If the inside end of the fiber is free during the rotational pay-out of fiber, the length straightens along the spool radius under the influence of centrifugal force. Although the pay-out fiber path is typically away from the nearest flange, turbulence or contact with part of the processing equipment machinery during traversing motion, may be sufficient to cause the fiber end to swing around and deflect back into the fiber path, generating whip damage as fiber is paid off. It is also conceivable that, if the inner end is unsecured and sufficiently long, the fiber end could swing back into the outer surface of the fiber spool and induce the type of damage indicated in Figure 1.

Figure 4. Turbulence causes the unsecured inner end to strike fiber in the pay-off path.

1. At the pay-out spool (particularly in coloring where the rotational velocity of the spool is greatest) ensure that a long inner end is not allowed to become detached from the outside of the flange. This may be achieved by cutting the inner end close to the slot and operating with the slot plug in position. Alternatively the inner end may be cut close to the slot and secured by a sufficiently well adhered sticker. See Corning Application Note 3683 for recommendations on cutting the inner end before processing. This document is available on the Corning Optical Fiber website at [http://www.corning.com/media/worldwide/coc/documents/Fiber/RC-Application Notes/AN3683_06-09.pdf](http://www.corning.com/media/worldwide/coc/documents/Fiber/RC-Application%20Notes/AN3683_06-09.pdf).

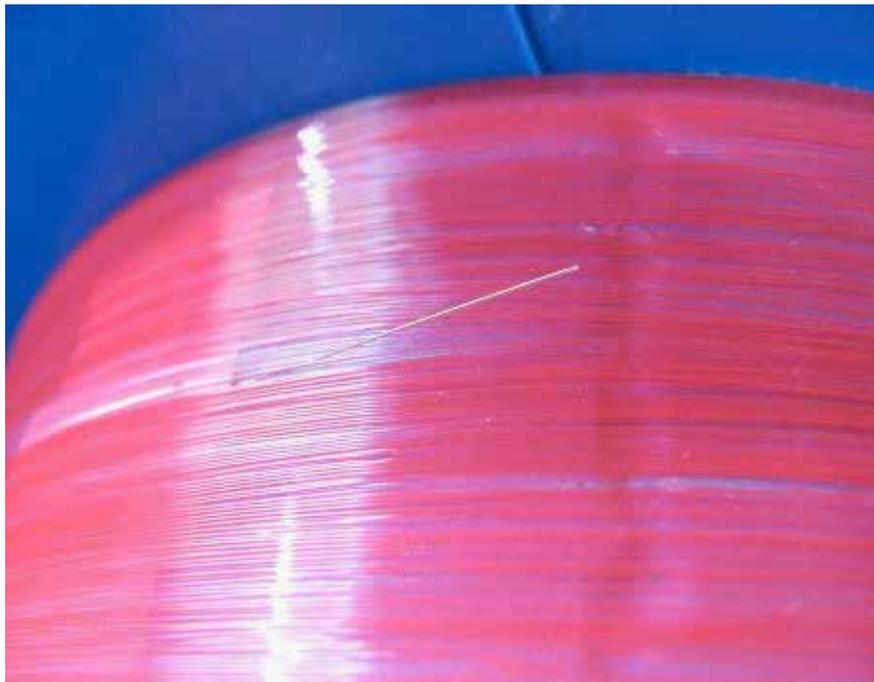
Corning has observed situations where the inside end is attached to the barrel of the take-up spool (rather than the outer flange) with tape or a sticker to cover the end. This arrangement is not recommended as the tape or stickers can release from the barrel during spool rotation and allow the fiber end to protrude from the fiber pack (see Figure 5). This loose fiber end can potentially cause whip damage. The fiber end should always be attached to the outer flange rather than the barrel.

Figure 5. An example of fiber-end whip source caused by insufficient adhesion of the fiber end to the barrel using a sticker.

2. At the take-up spool, secure the fiber from the pay-out spool (after threading up through the machine) by passing it through the slot and securing to the lead-meter side flange. Carefully rotate the take-up spool by hand to remove any slack in the fiber path. Do not attach fibers to the spool barrel.

3. While Corning discourages the use of stickers, if doing so, ensure that the sticker is properly applied to cover the fiber end and the adhesion is sufficiently strong so as to remain in place when the spool begins to rotate. Use stickers only once - do not attempt to re-use stickers for multiple spools.

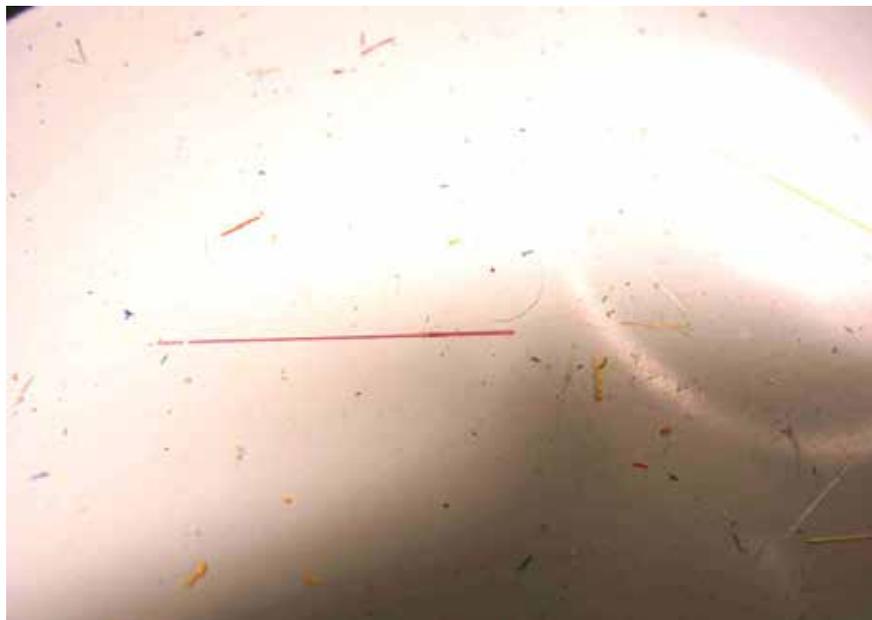
Finally, it needs to be recognized that when whip damage leads to a break event, the shattering of the fiber may lead to the generation of multiple fiber shards in the region of the processing equipment. If not efficiently removed from the area, these shards may become mobile in the circulating air, lodge in the fiber path, and propagate more breaks through penetration by the shard of the coating to damage the glass. Figure 6 shows a coloring surface from which debris from previous breaks has not been removed, increasing the probability of further breaks on the line.

Figure 6. A coloring surface contaminated by shards from previous break events.

5. Immediately after a fiber break event, ensure a thorough clean-down procedure is followed to eliminate glass shards from the area of the processing equipment. Appropriate cleaning following a break can include vacuuming of the processing surfaces and using an alcohol soaked cloth to wipe down the pulleys, capstans and dies of the fiber path. A disposal bin should be located close to the processing equipment to dispose of any shards or fiber ends generated in operating the equipment. If a break is suspected to have induced whip damage in the outer surface windings, remove sufficient fiber from the outside of the spool to ensure the damaged section is eliminated. This prevents more breaks being propagated in further processing. Removal of up to 2 km of fiber may be required for this purpose.
