# Mechanical Behavior of Optical Fibers Removed From a Field-Aged Cable

Jeffrey L. Smith, Anurag Dwivedi, and Patrick T. Garvey  
Corning Incorporated, Corning, NY 14831

**TR1088**

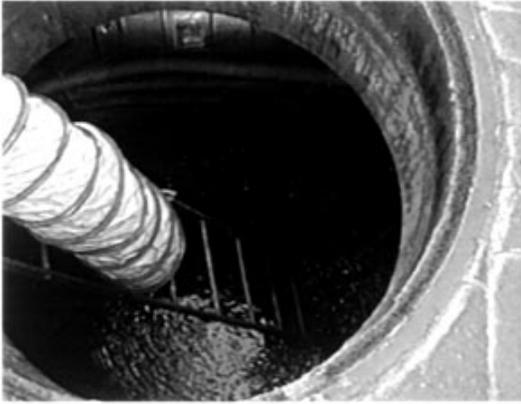
Figure 2: Conduits submerged in water inside the manhole.

The cable tested in the present study was installed in an underground conduit between buildings in Corning, NY. The cable was manufactured in 1985 and left in a warehouse in an uncontrolled environment for just over two years. It was first installed in September 1987, and then re-routed in April 1992. The segment tested in the present study was an excess piece that was removed during this re-routing. The underground conduit which held the cable is located within 150 meters of a river. Based on periodic inspections of the manhole, this conduit would frequently fill with water, often submerging the cable (Figures 2 & 3). The cable was dissected and fibers were carefully removed in 1994 for mechanical testing. At the time of testing, the fibers had been in the cable for about nine years and the cable had been in a field installed state for a period of five years. According to the National Weather Service, the average lowest temperature in the Corning NY region is 14°F and average highest temperature in 80°F.

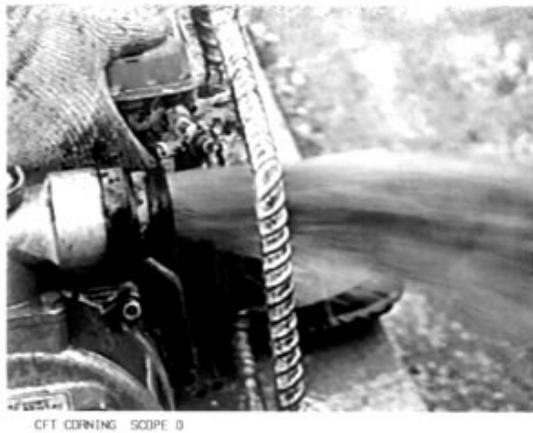
Figure 3: Water being removed from the manhole using a water pump.
