Fracture Analysis, a Basic Tool to Solve Breakage Issues

Technical Information Paper

Display
Technologies

TIP 201

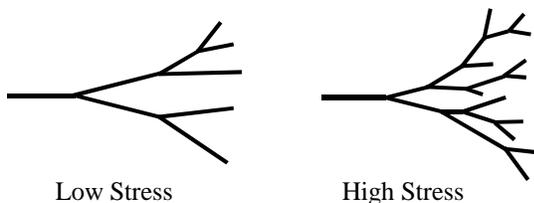
Forking: Forking is crack branching. Qualitative magnitude of applied stress can be known from number of cracks forking as shown in Fig. 1.

Fig. 1 Forking with high and low stresses

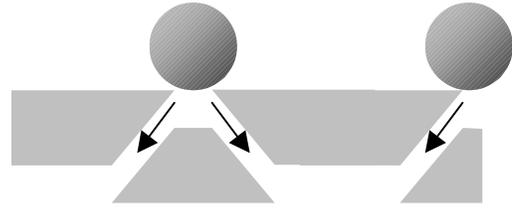
Hertzian cone: Hertzian cone crack is created by localized impact with blunt hard object. Schematic illustration of the Hertzian cone creation is shown in Fig. 2.

Fig. 2 Schematic illustration of Hertzian cone crack creation from cross sectional view.

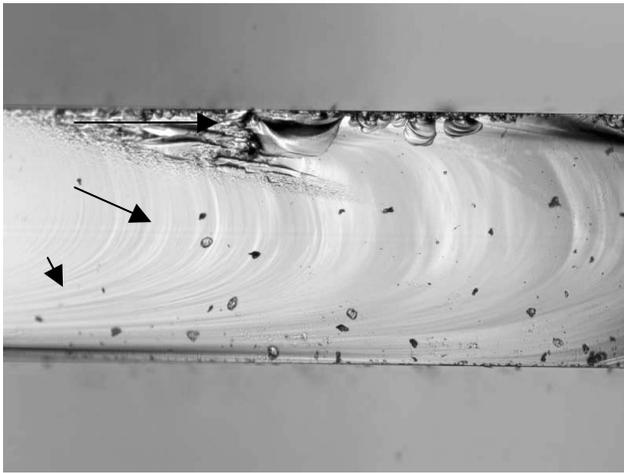
Wallner lines: Wallner lines are rib shaped marks as shown in Fig. 4, which indicate crack propagation direction. The Wallner line is perpendicular to the crack propagation direction. There are three types of Wallner lines that are very useful in determining the course of events. These are primary, secondary and tertiary. Primary wallner lines indicate that a surface or internal flaw was present prior to the failure event. Secondary wallner lines occur when the fracture approaches terminal velocity, and tertiary occur as a result of a mechanical shock, vibration or impact outside the crack front.

Fig. 4 Secondary Wallner lines created by crack propagation with bending stress. Cracks run left to right (arrow mark).

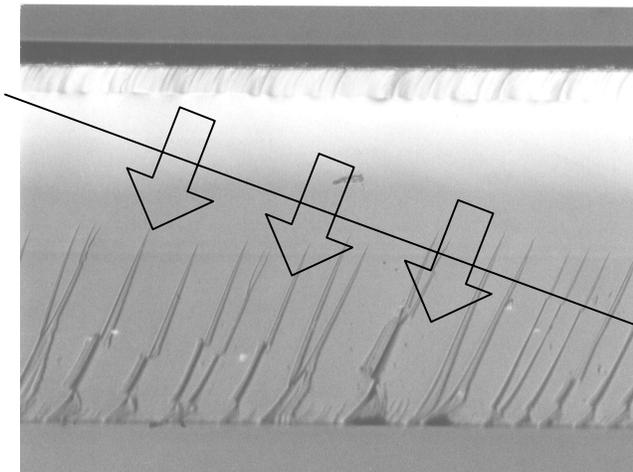
Fig. 5 Typical Twist Hackle mark created by breaking process following scribe process. Crack front was perpendicular to the Twist hackle marks, and crack propagation direction was parallel to the mark.

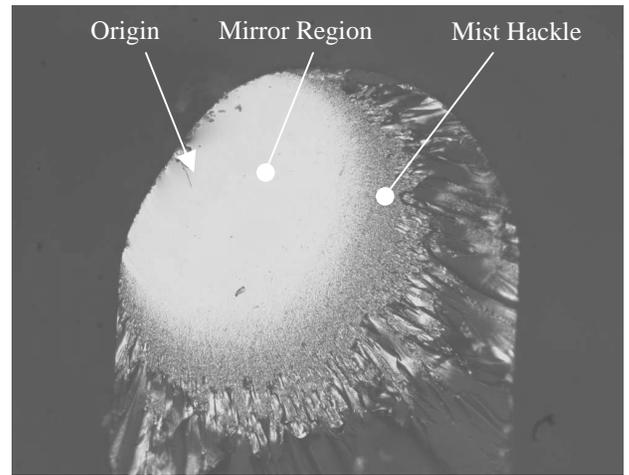
Fig. 6 Fracture surface around origin. Origin is surrounded with mirror region, which is covered with mist Hackle mark. Failure stress can be estimated using radius of the mirror region.

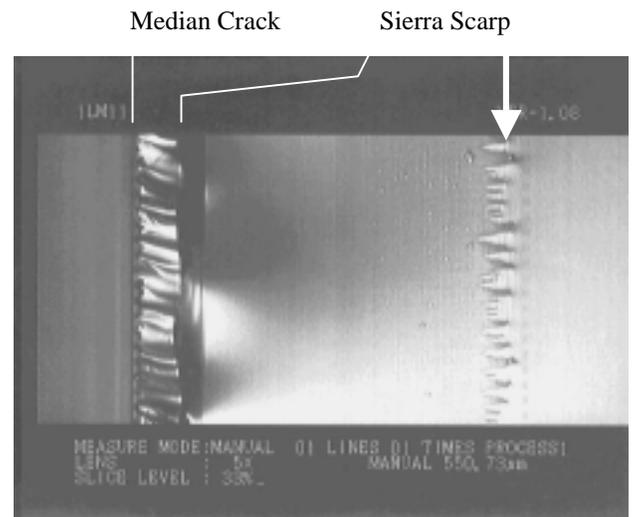
Fig. 7 Sierra Scarp appears on a fracture surface created by scribe/break process. Water was existed during median crack propagation

Sierra scarp: When water is exist at crack front during the crack propagation, Sierra scarp appeared.

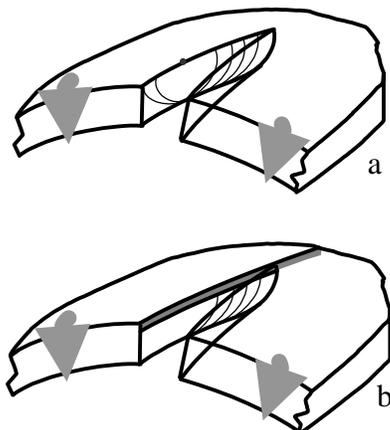
Therefore, glass cutting process using scribe/break method is a controlled breakage, where the crack propagates only along the scribe line. Cracks of the glass sheet cutting is the controlled breakage shown in Fig. 13. The scribe line, is an origin of the breakage, which crack propagation along with the scribe line is origin of separation of the sheet. The fracture analysis is useful tool for the optimization of the process, and/or analyze cause of faulty cutting, cracks run freely.

Fig. 13 Schematic illustration of (a) breakage and (b) cutting. Only difference between (a) and (b) is origin of crack propagation. Irregularly created damage as origin for breakage (a) and median cracks created with scribing as controlled origin for the cutting (b).
