# Fiber Cleanliness in the Data Center – The Impact of Contamination

Authors:  
Martin Hempstead  
Eric ten Have

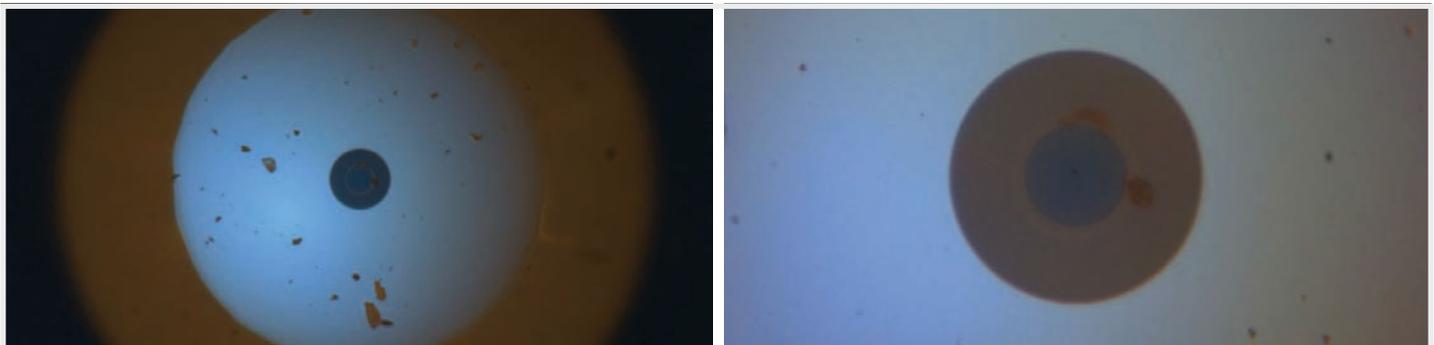
Figure 9: Results of exposure of initially clean LC connector, with end face up, to ambient air over approximately one week. Left: Full end-face field of view. Right: Expanded fiber area.

While this does occur, it is at a very slow rate, and will typically result in loosely adhered debris that is easily removed. Figure 9 below shows some initially clean connector end faces that were mounted facing vertically upwards and exposed to air in a typical non-cleanroom environment for about one week. Clearly the rate of dust arrival is very slow, which is borne out by the fact that it is not common – although neither is it extremely rare – to see particles arrive on an end face while it is being inspected. The arrival rate and adhesion forces probably both depend on the state of the electrostatic charge of the end face. We have measured significant voltages (in some instances with magnitudes around 500 V) on end faces and even higher on other surfaces such as parts bags; the level of static charging is presumably influenced by humidity, by handling, and by friction during capping/uncapping.
